Redevelopment of the Old Waste Incineration Plant in Poznań: Contribution to the Discussion on the Approach to Post-Industrial Cultural Property

Cytowanie / Citation: Marciniak P. Redevelopment of the Old Waste Incineration Plant in Poznań: Contribution to the Discussion on the Approach to Post-Industrial Cultural Property. *Wiadomości Konserwatorskie – Journal of Heritage Conservation* 2021, 68S:

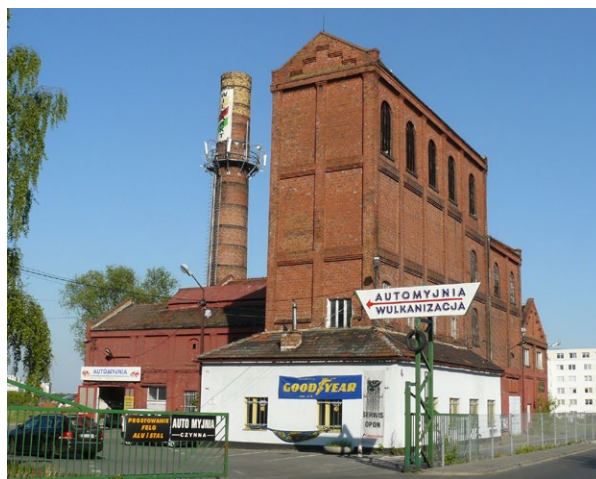
Fig. 4. Incineration Plant, image from 2007 showing the missing smokestack top and the additions on the ground level; photo courtesy of Litoborski+Marciniak.
Ryc. 4. Spalarnia, zdjęcie z roku 2007 ukazujące brakujący czubek komina oraz dobudówki na poziomie parteru; fotografia dzięki uprzejmości Litoborski+Marciniak.

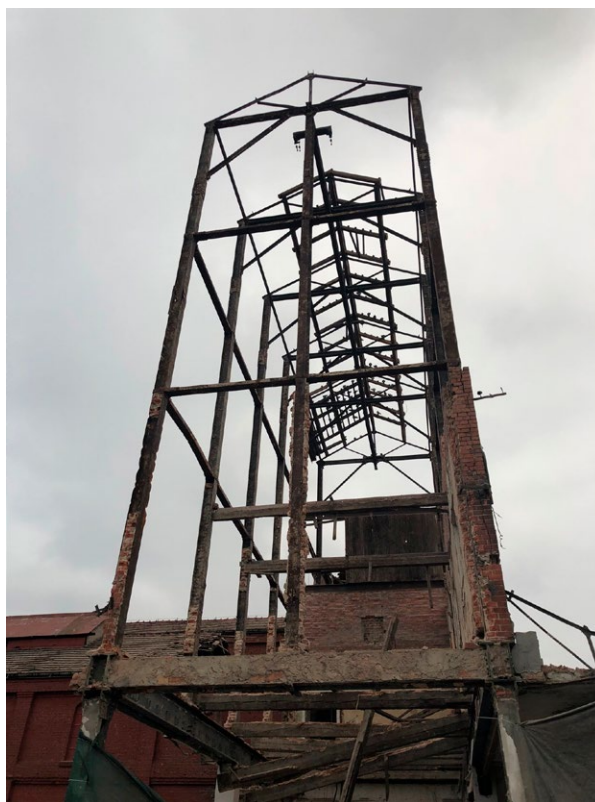
Another expert survey of 2017 confirmed the property's dramatic technical condition, including a threat to the structural stability of the high part of the incinerator building and the smokestack, which deviated from the vertical by 13 cm. Of crucial significance was the deterioration of the "existing steel structure

which [was] coupled with the column structure of the walls,²⁰ as well as numerous vertical cracks in the plasters reinforcing the external walls.

Fig. 5. The high section during the demolition of the deformed and cracked walls with visible corroded steel structure; photo by P. Paradziński.

- ²⁵ Ustawa z 7 lipca 1994 Prawo budowlane, Dz.U. 1994, No. 89, item 414, as amended.
- ²⁶ These included mainly a longitudinal fracture in a gable wall, fractured pillars, deformed gable walls, corroded steel structure, fractures in the smokestack, etc. See: expert surveys specified earlier in the article.

3. Due to the building's poor technical condition, the highest north-western large-volume part, the roof structure and cladding, and the smokestack were demolished. They were then reconstructed retaining the layout of the block and facade but using modern construction techniques (layered walls with ceramic cladding).

solutions. The deteriorated inner steel structure was replaced by a reinforced concrete one, which met strict fire safety regulations. A few internal walls were also demolished and rebuilt. The foundation of part of the reconstructed section was made on a reinforced concrete slab. The internal foundations under the columns and under the new internal walls were made of reinforced concrete footings and benches, respectively. The building's structural system, due to fire protection requirements (for a mid-high building), was designed as a massive structure using the spatial formwork calculation model. This featured reinforced concrete columns and binders, and 18-cm-thick multi-area Filigree floor slabs. The walls of the upper stories were made of 20-cm-thick reinforced concrete. The existing outer brick walls were fixed to the new reinforced concrete structure with steel ties (anchors).

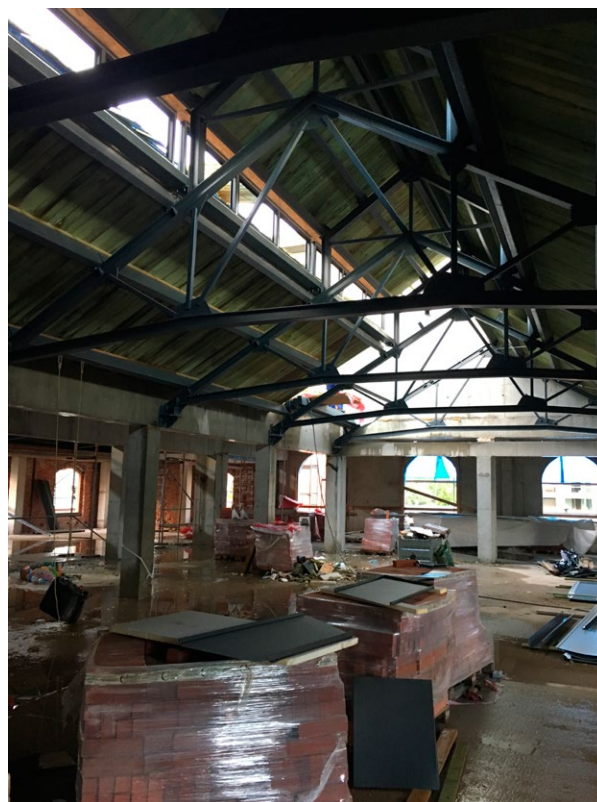
Another difficult feature was the roof. The existing roof covering, and above all the steel structure, were corroded and did not meet modern strength standards. The existing purlin and rafter roof based on steel lattice girders was dismantled and replaced with new steel lattice trusses meeting the current, revised regulations

Fig. 8. Second floor interior of the lower part of the plant, visible reconstructed steel structure of the roof; photo by P. Marciniak
Ryc. 8. Wnętrze drugiego piętra niższej części zakładu, widoczna zrekonstruowana stalowa konstrukcja dachu; fot. P. Marciniak.

for snow and wind loads, as well as taking into account the need for roof insulation and adequate fire protection. Roof pitches and truss heights were modelled on the original trusses, as were the purlin and rafter structures. The roofing was made of graphite-colored coated steel with a standing seam. The gutters, downpipes, roofing and other details were adapted to the color and architectural expression of the roof and its structure and were made of similar material.

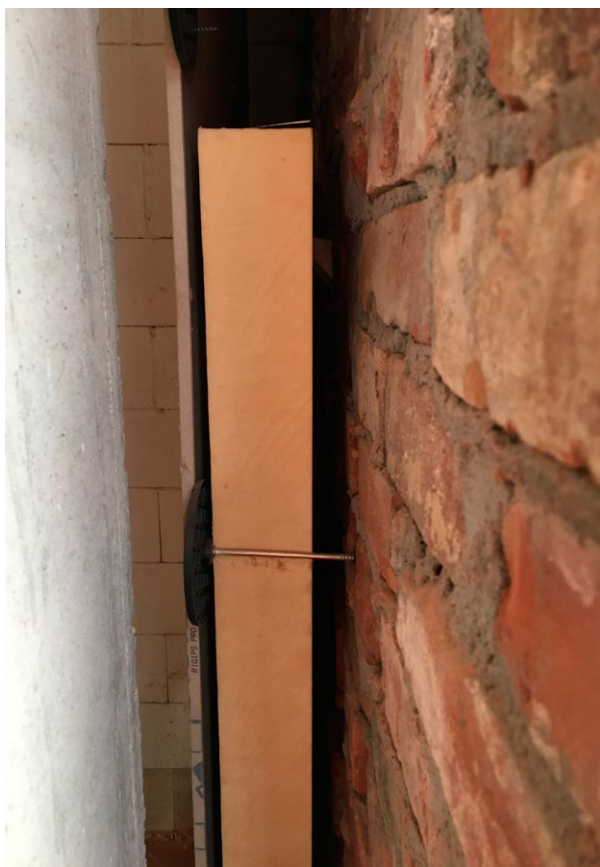
Fig. 9. Thermal wall insulation installed from the inside; photo by P. Marciniak.

The remaining external brick walls, after appropriate treatment (replacing missing bricks and damaged sections, removing dirt and light red paint coating, etc.) were preserved to serve as wall cladding, strengthened from the inside with a new reinforced concrete support structure. The entire facade of the building, after repairing the bricks, producing new ones and restoring the old openings, was grouted to obtain a uniform, coherent architectural expression, whilst preserving and exposing the historical layers.
